# SigmaGlide Case Study

SPEEDONE  
Passenger/ro-ro ferry; built 1997; GRT 5,007  
operational speed 42 kn

Inspected in Portsmouth, UK (February 2004)

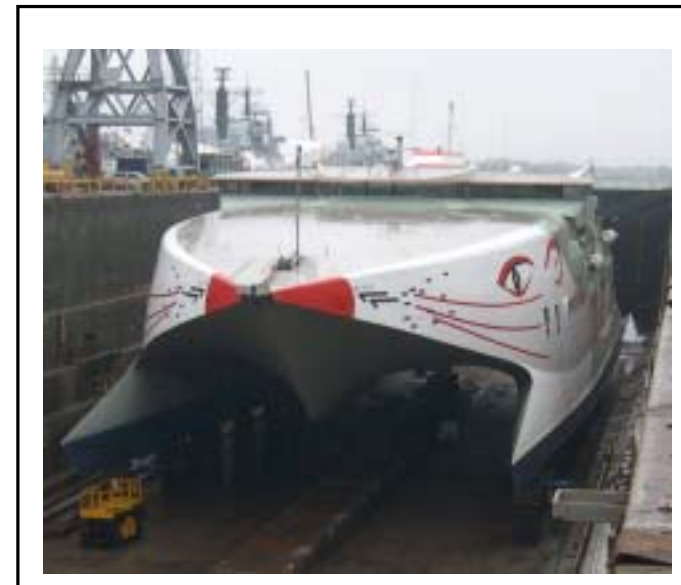
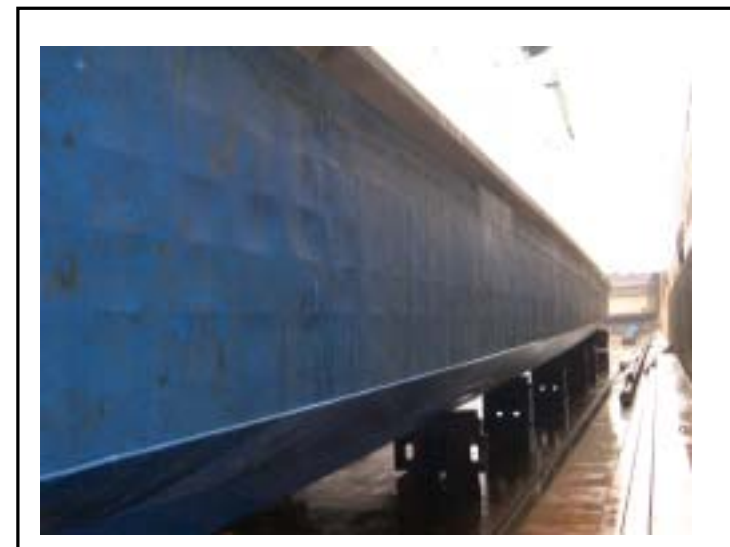
In August 2002 vessel was chartered to an Italian ferry operator and thereafter 12 months laid up in Portland, UK. The image on the right shows the vessel in drydock in Portsmouth prior to going on charter, with only slime on SigmaGlide-coated areas; the trip to the drydock was enough to remove fouling settlement observed in Portland. Fouling threat can be seen on unprotected areas (old keel blocks) where barnacles and tubeworms predominate. Vessel was only low-pressure, fresh water washed before returning to service.
